TECOM
~~TECHNICAL REPORT~~ TR-RD-TE-95-16

TEST REPORT OF THE DIRECT STRIKE LIGHTNING TEST OF THE MCC-1
THERMAL PROTECTION SYSTEM (TPS) COATED ALUMINUM PANELS

19 May 1995

This report presents the test procedures and results of the direct strike lightning effects test on the Marshall Convergent Coating -1 (MCC-1) Thermal Protection System (TPS) coated aluminum frustum and aft skirt panels.

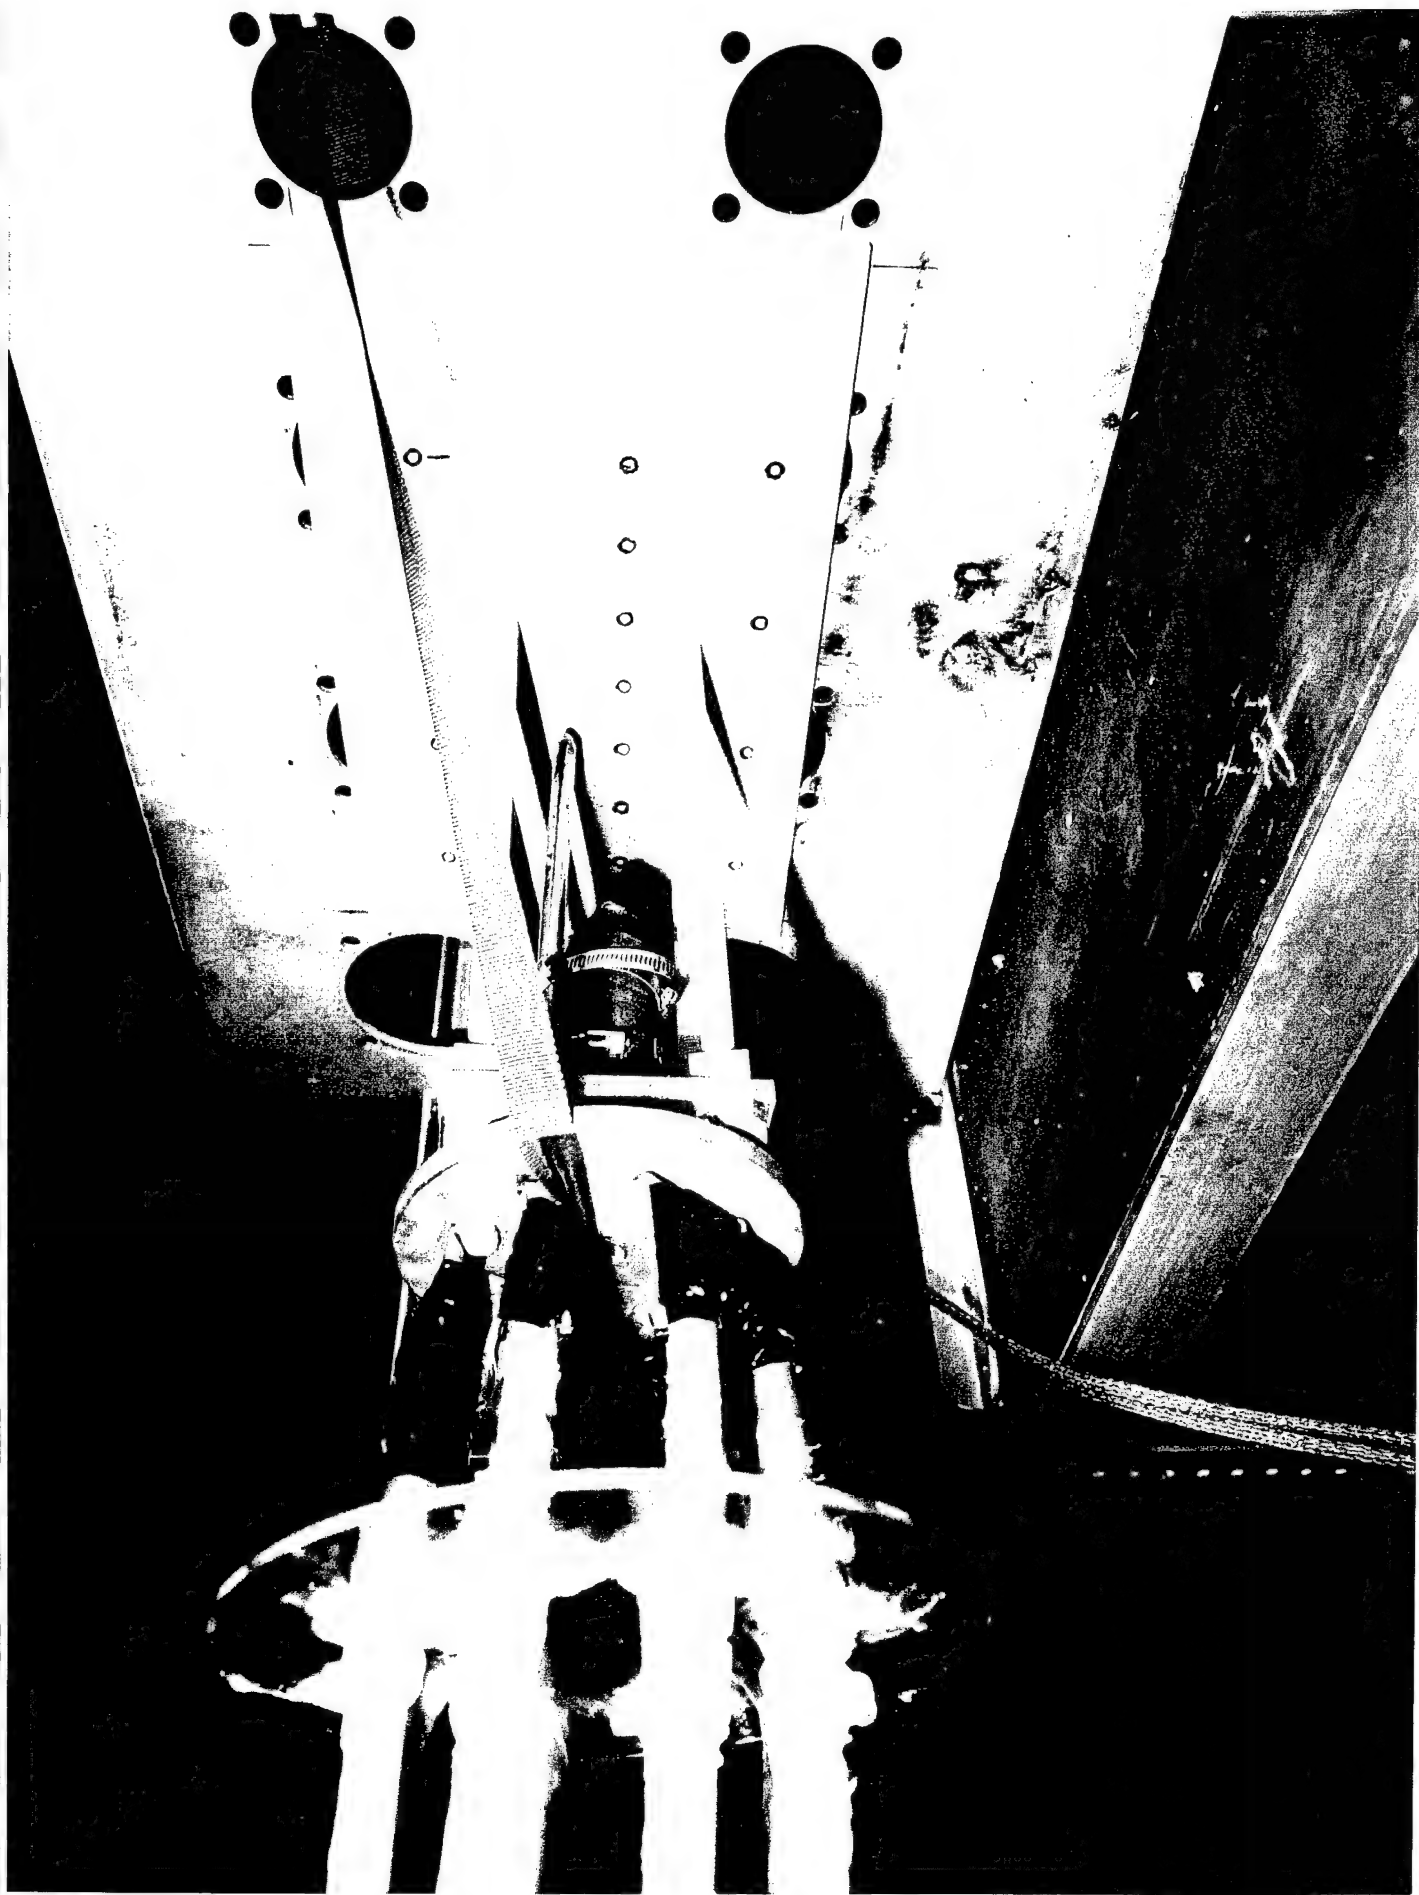
Figure 7. Test Setup for High Current and Continuing Current Lightning Tests.

11. Repeat steps 1 through 9 for the continuing current (Component C) lightning generator. The test setup for the continuing current lightning test was identical to the test setup for the high current lightning test (see Figures 7, 8, and 9) except the discharge probe was positioned 0.25 inches from the panel.

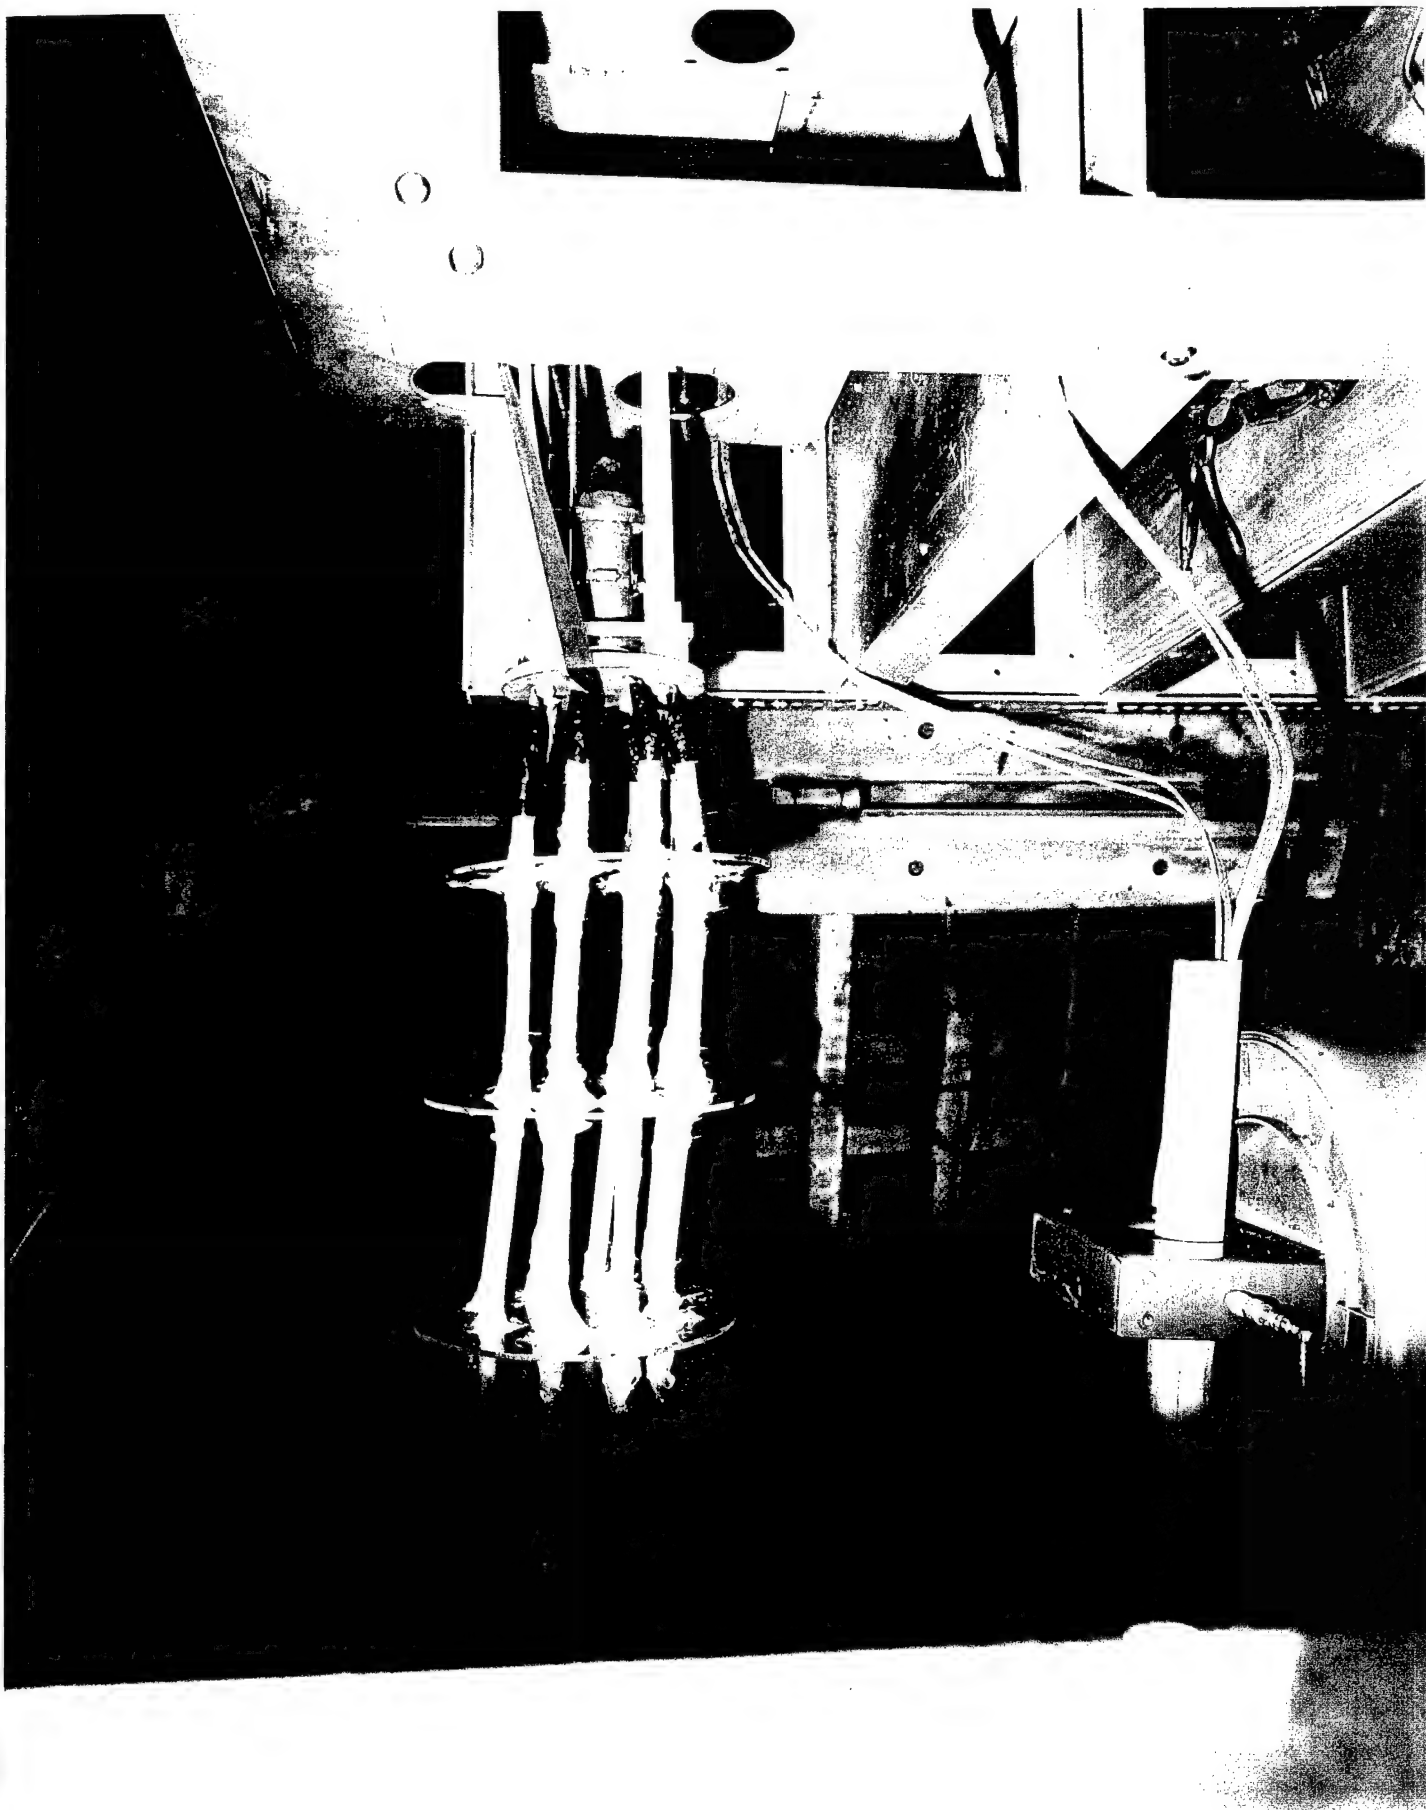
Figure 8. Test Setup for High Current and Continuing Current Lightning Tests.

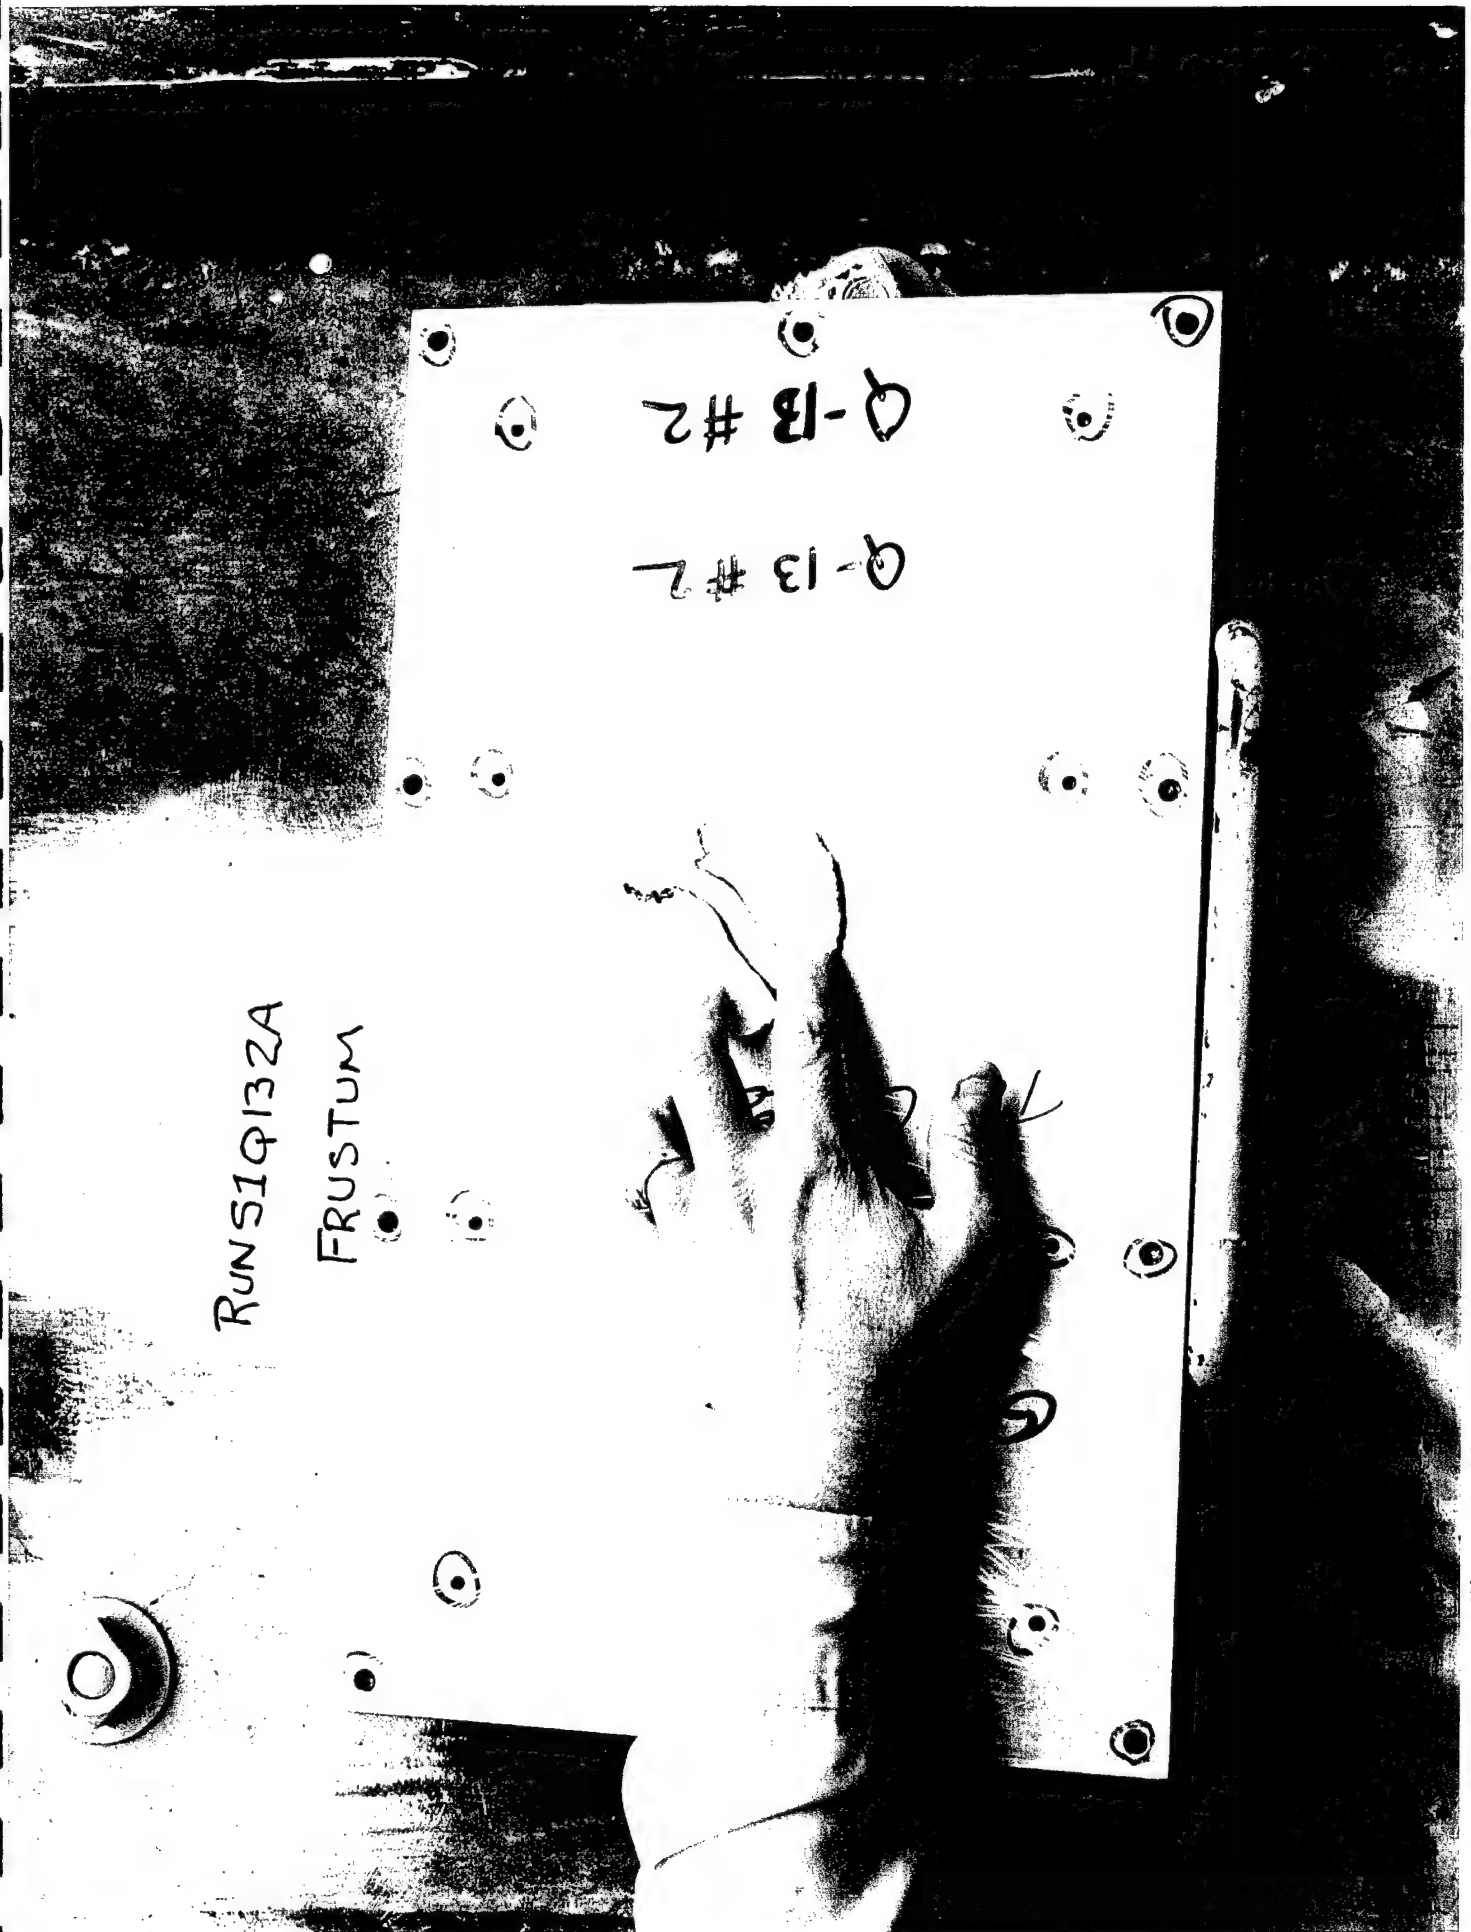
Figure B-10. Resultant Damage Due to Component A to Panel Q-13#2, Back View with Pieces.

All of the panels experienced loss of MCC-1 TPS coating at the point of discharge due to the application of the high current (Component A) direct strike lightning environment. The amount of MCC-1 TPS coating loss varied from panel to panel and seemed to depend on how well the material was bonded to the aluminum panel. The application of the intermediate current (Component B) and the continuing current (Component C) direct strike lightning environments resulted in a small melted spot on the aluminum panels with no additional loss of MCC-1 TPS coating. The application of the restrike current (Component D) direct strike lightning environment resulted in slight blackening of the MCC-1 TPS coating around the area of the discharge point with, again, no additional loss of MCC-1 TPS coating.

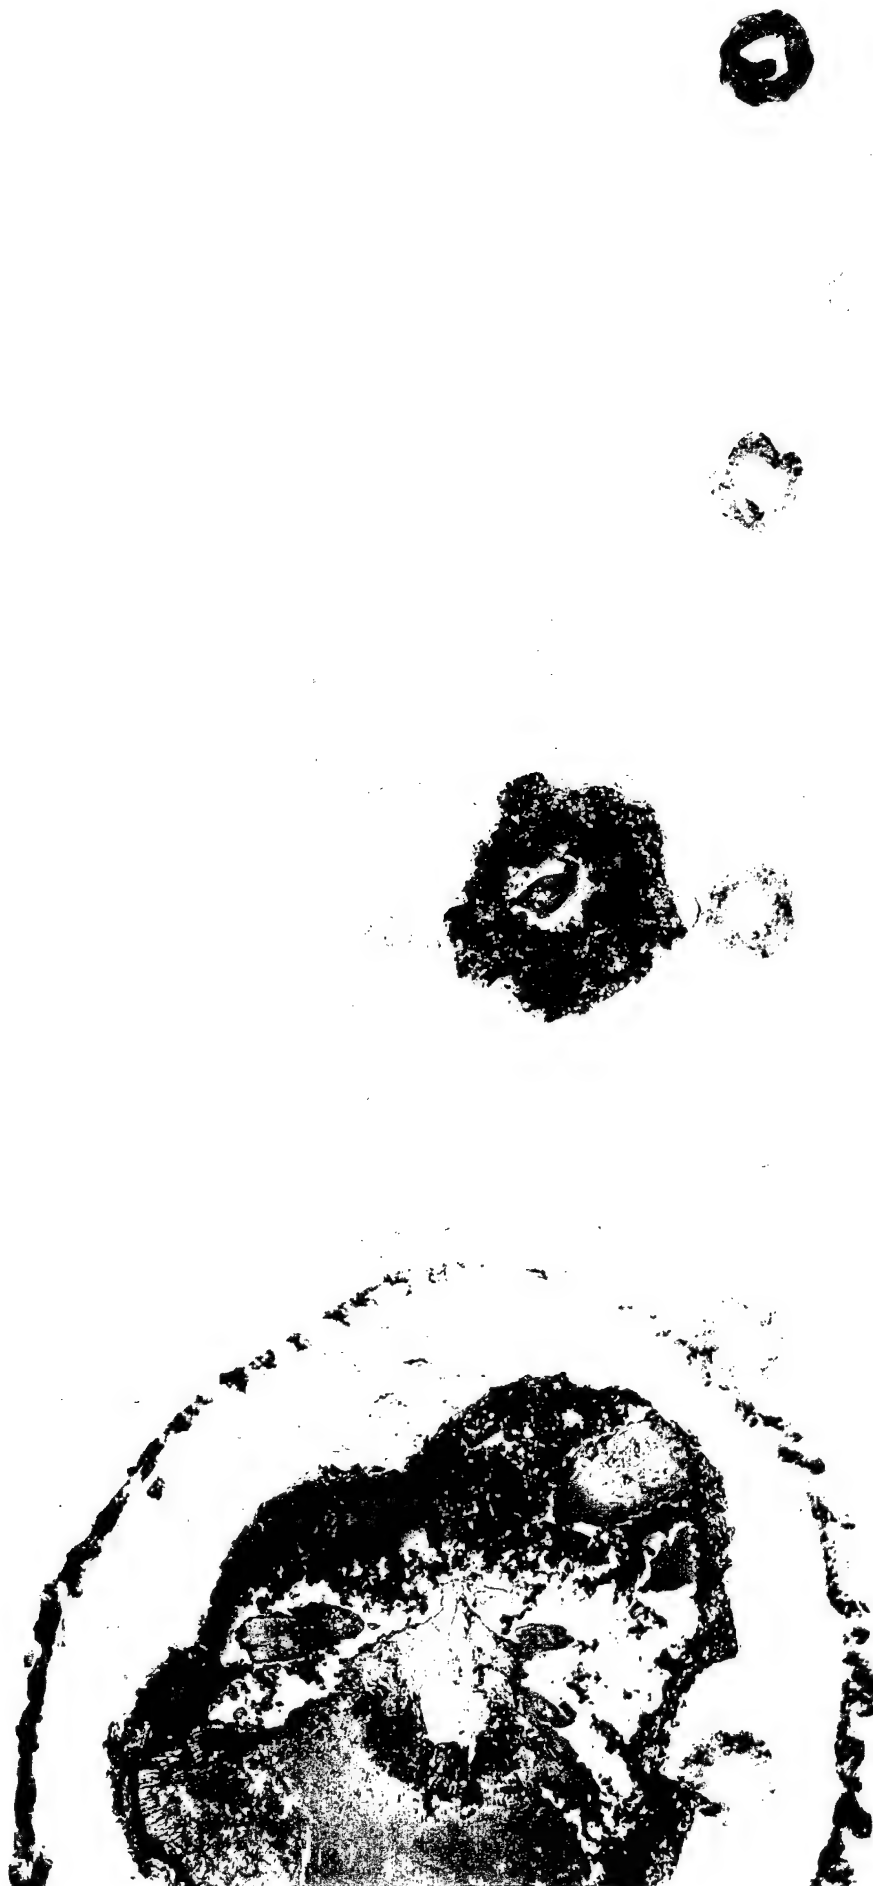
Figure B-20. Cumulative Damage Due to Components A and B to Panel Q-6#9, Close Up View.

The application of the intermediate current (Component B) direct strike lightning environment resulted in a small melted (burn or blistered) spot on the aluminum panels approximately 1/4-inch in diameter. No additional loss of MCC-1 TPS coating was observed to occur due to the application of the intermediate current direct strike lightning environment. Figures B-19 through B-36 of Appendix B illustrate the cumulative damage on each panel due to the applications of the Component A and the Component B direct strike lightning waveforms.

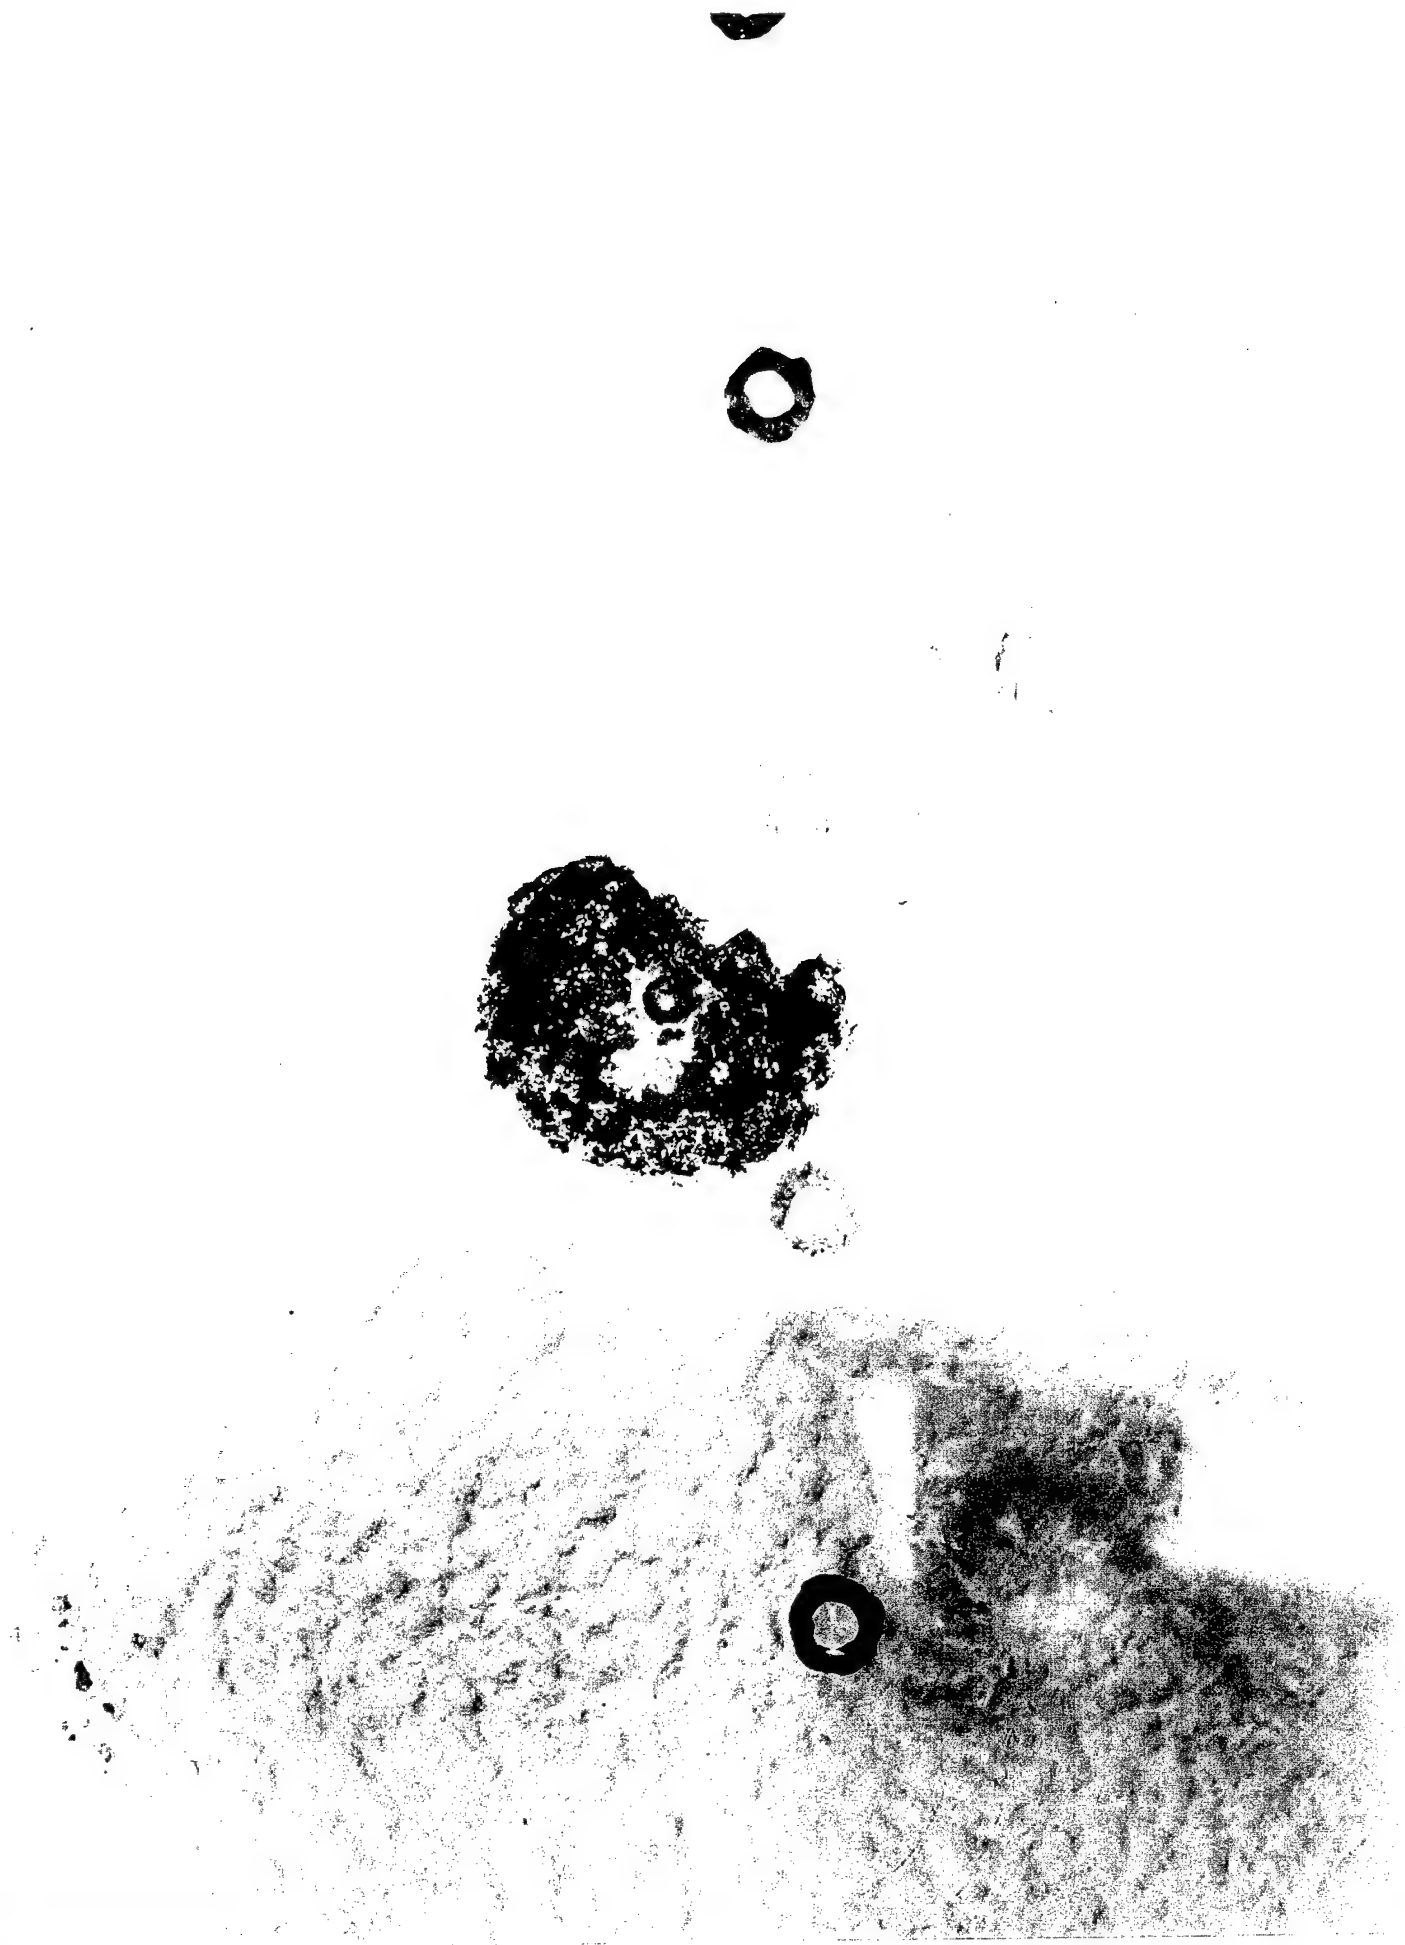
Figure B-23. Cumulative Damage Due to Components A and B to Panel Q-6#10, Close Up View.

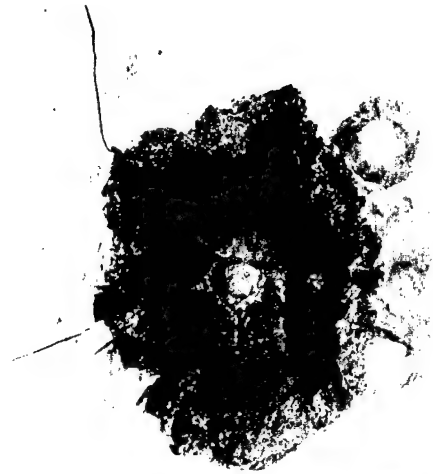
Figure B-29. Cumulative Damage Due to Components A and B to Panel Q-II#6, Close Up View.

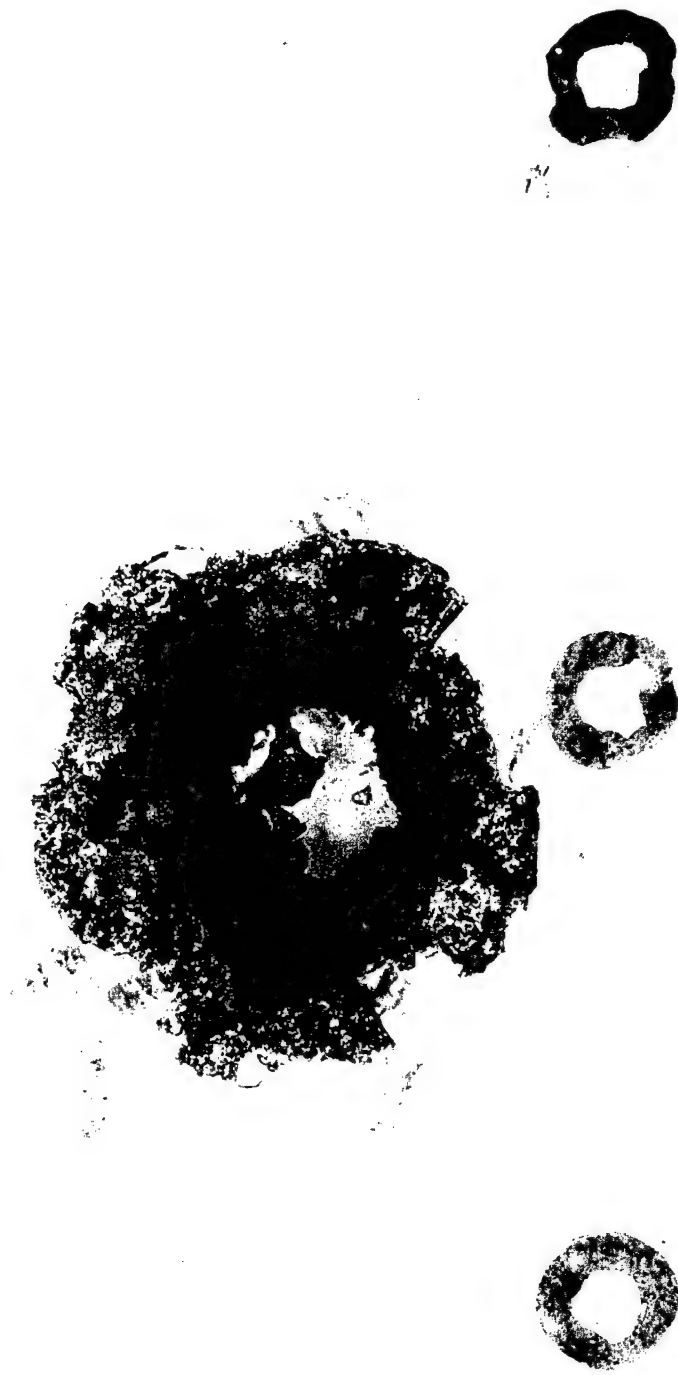
Figure B-35. Cumulative Damage Due to Components A and B to Panel Q-11#9, Close Up View.

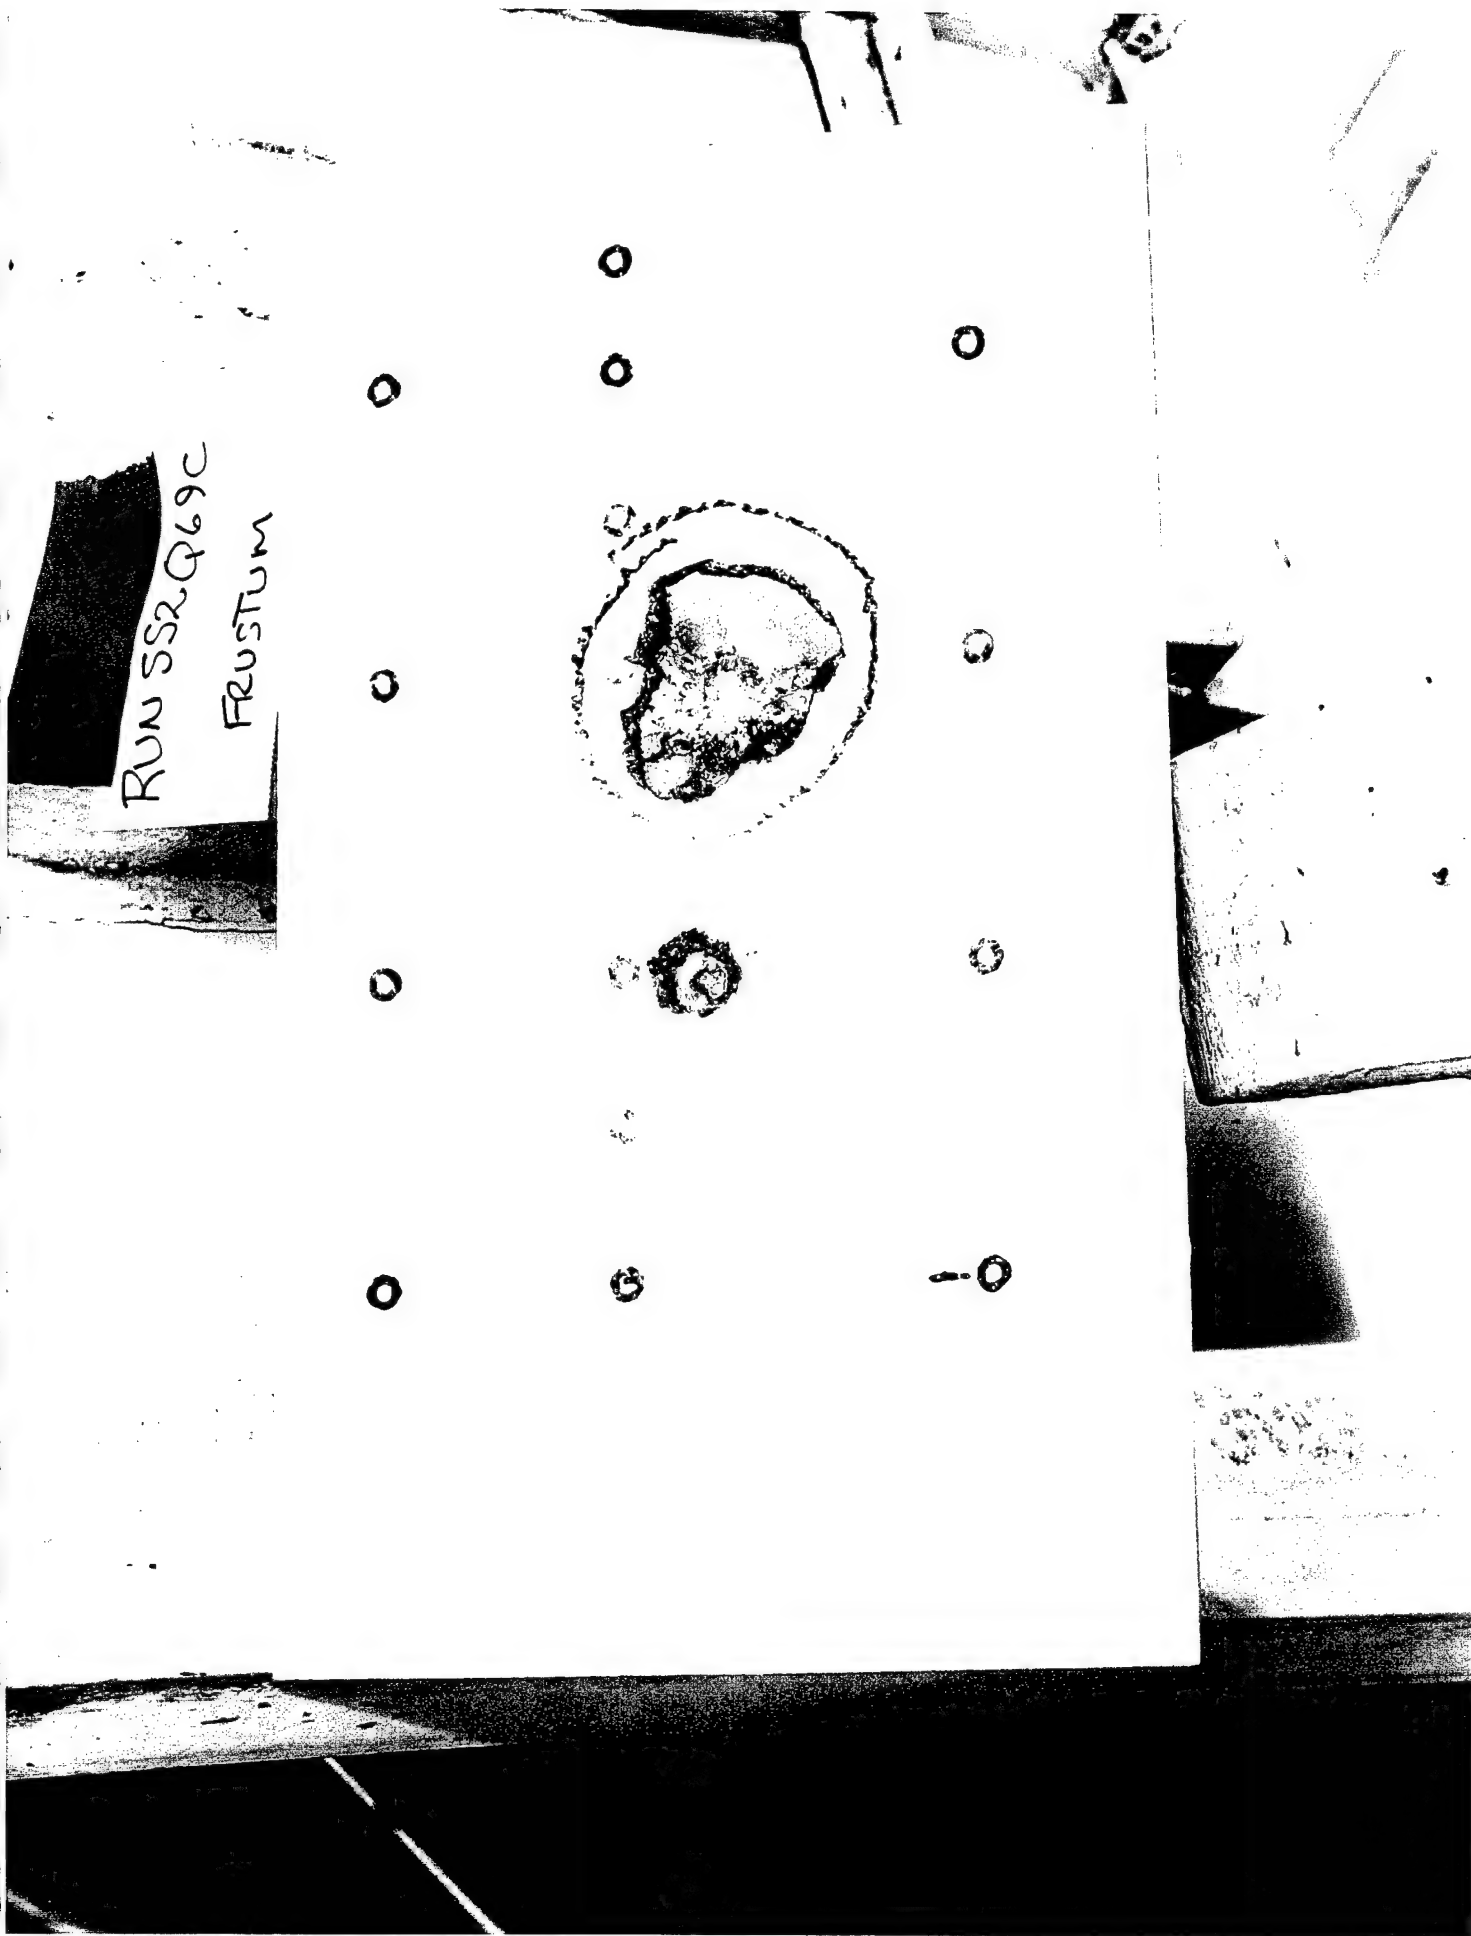
Figure B-37. Cumulative Damage Due to Components A, B, and C to Panel Q-6#9, Front View.

The application of the continuing current (Component C) direct strike lightning environment resulted in a melted (burn or blistered) spot on the aluminum panels of up to approximately 3/4-inch in diameter. No additional loss of MCC-1 TPS coating was observed to occur due to the application of the intermediate current direct strike lightning environment. Figures B-37 through B-54 of Appendix B illustrate the cumulative damage on each panel due to the applications of the Component A, the Component B, and the Component C direct strike lightning waveforms.

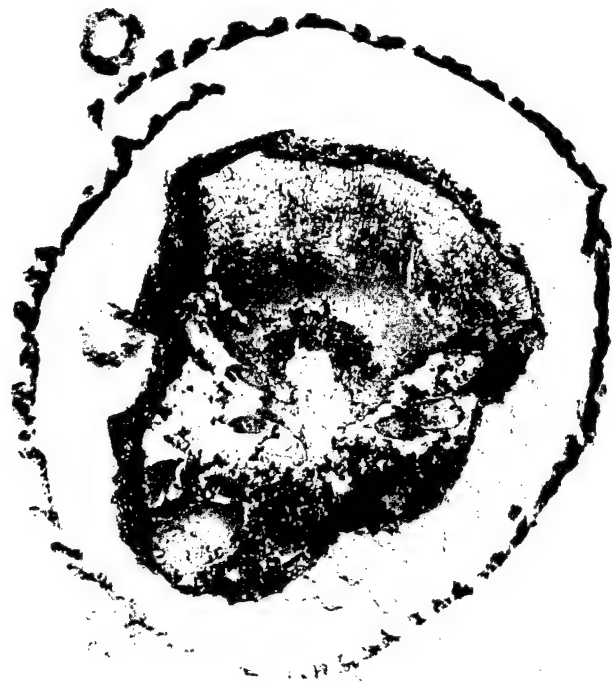
Figure B-38. Cumulative Damage Due to Components A, B, and C to Panel Q-6#9, Close Up View.

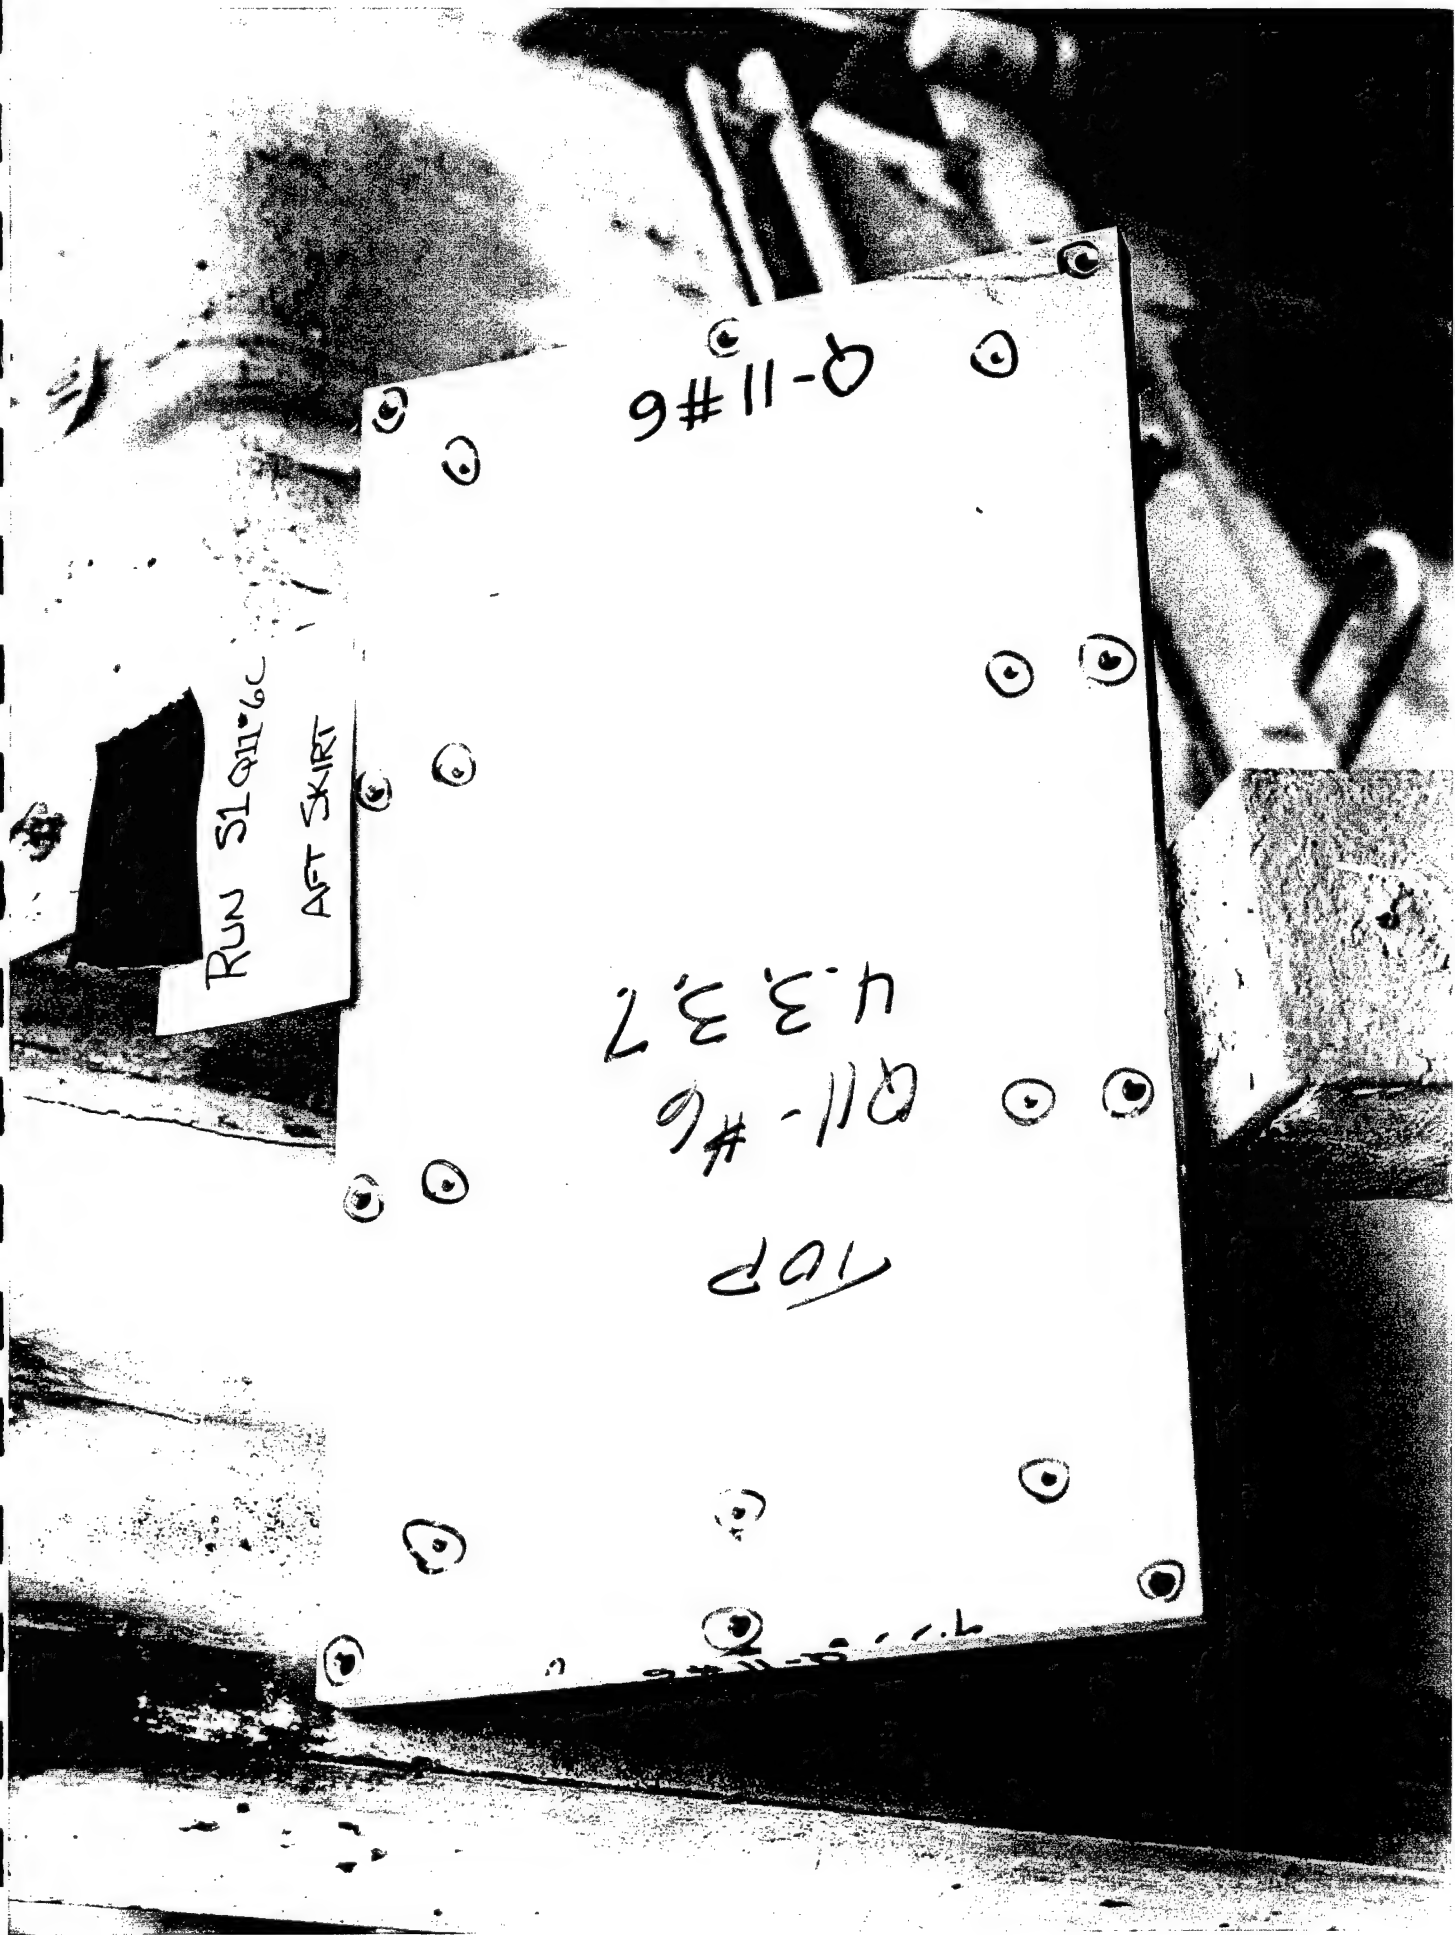
Figure B-48. Cumulative Damage Due to Components A, B, and C to Panel Q-11#6, Back View.

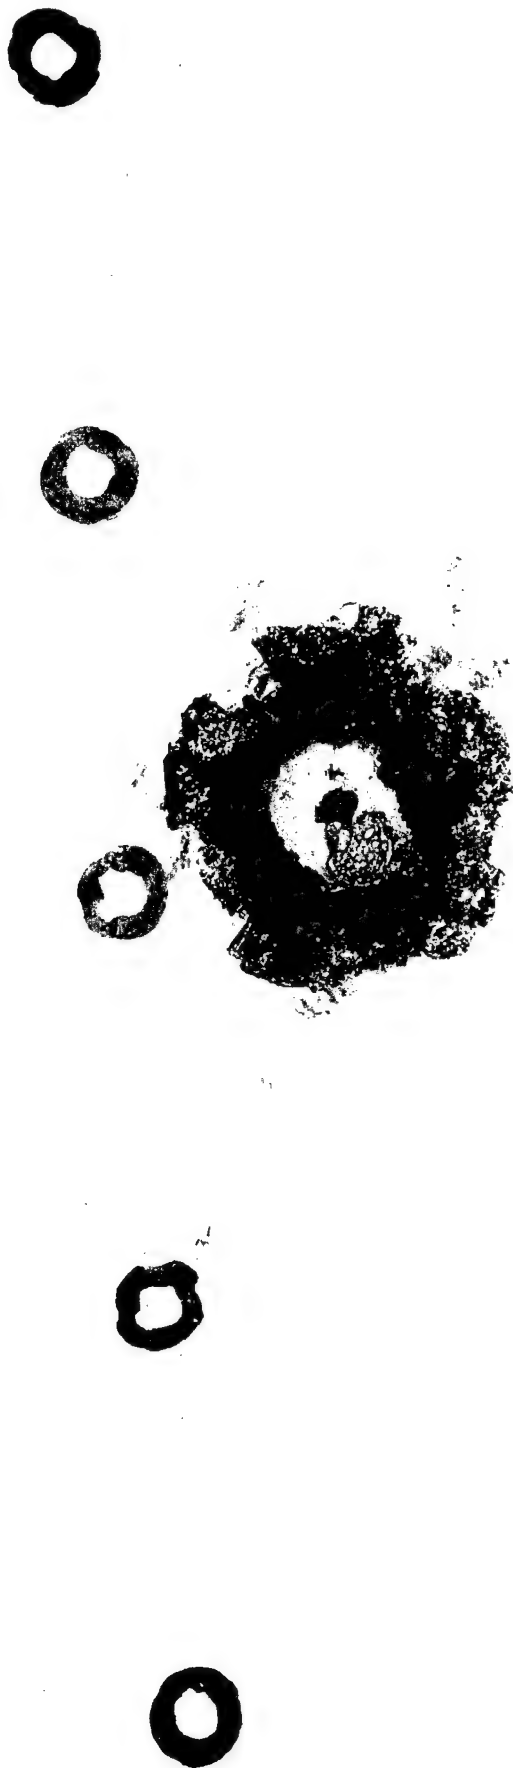
Figure B-53. Cumulative Damage Due to Components A, B, and C to Panel Q-11#9, Close Up View.
